INSPECTION REPORT  
FOR  
BRIGHTON LANDFILL NO. 1  
Brighton, IL  
ILD980497671  
R05-8410-01C

June 25, 1986

SUBJECT: Illinois/R05-8410-01C/IL0386

Brighton/Brighton Landfill No. 1

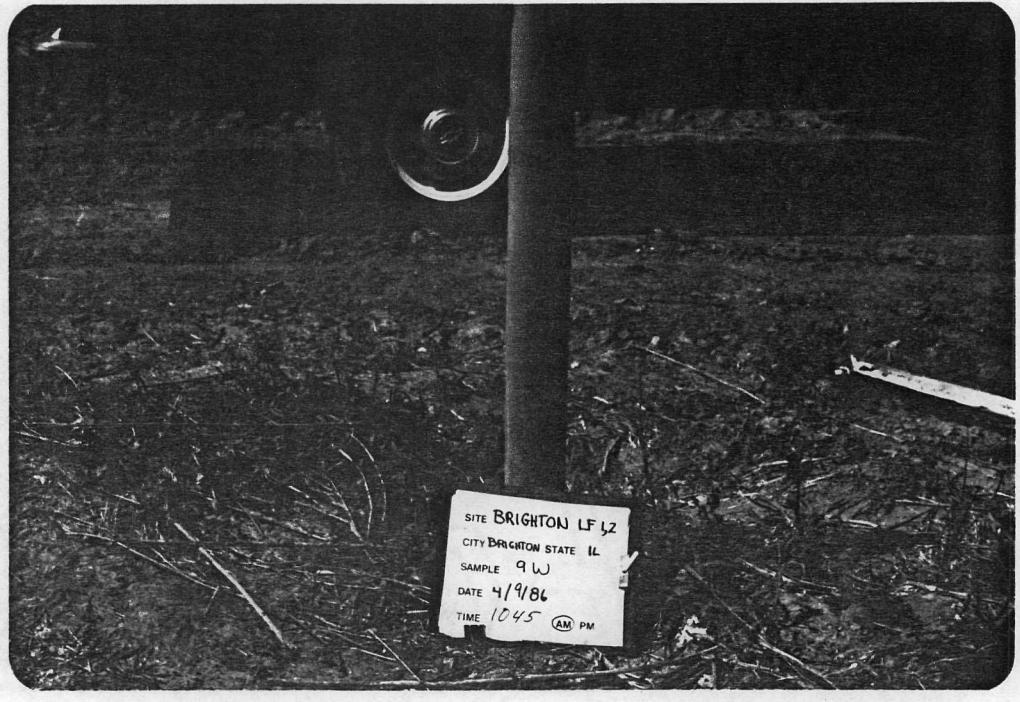
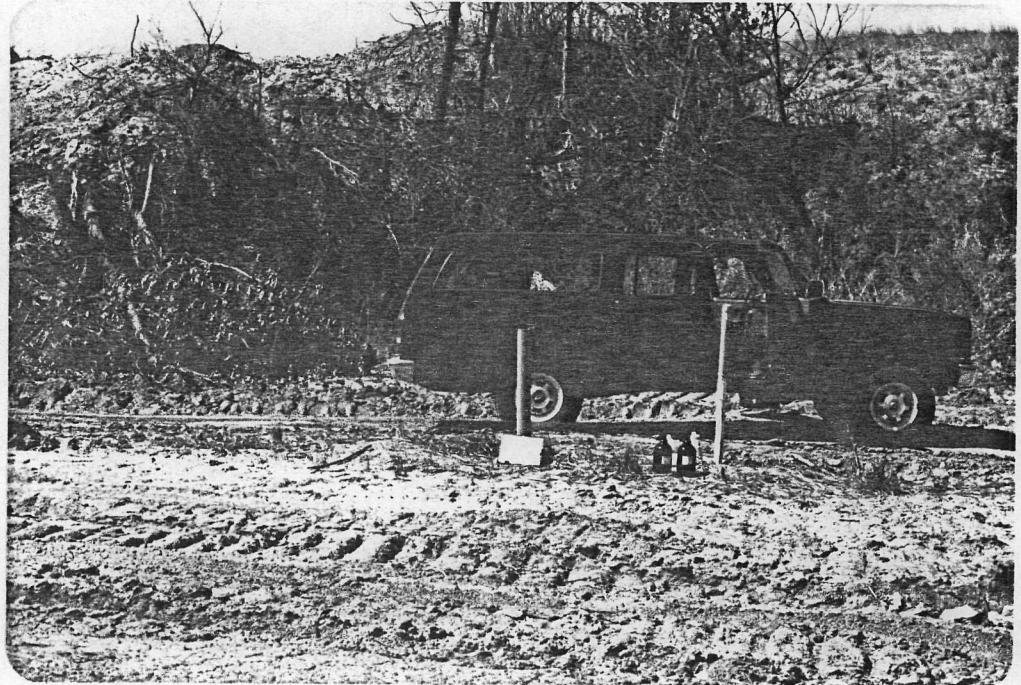
9W

DESCRIPTION: Well # A1295 located at Northeast corner of filled area near creek.DATE 4/9/86TIME 1045 (A.M. P.M.)DIRECTION: N NNE NE ENE  
E ESE SE SSE  
S SSW SW WSW  
W WNW NW NNWWEATHER sunny

DESCRIPTION: Same as above from ~ 20 ft.
